CONNECTICUT RIVER BASIN  
WESTFIELD, MASSACHUSETTS

ARM BROOK  
MULTIPLE PURPOSE DAM  
MA 00604

PHASE I INSPECTION REPORT  
NATIONAL DAM INSPECTION PROGRAM

AUGUST 1978

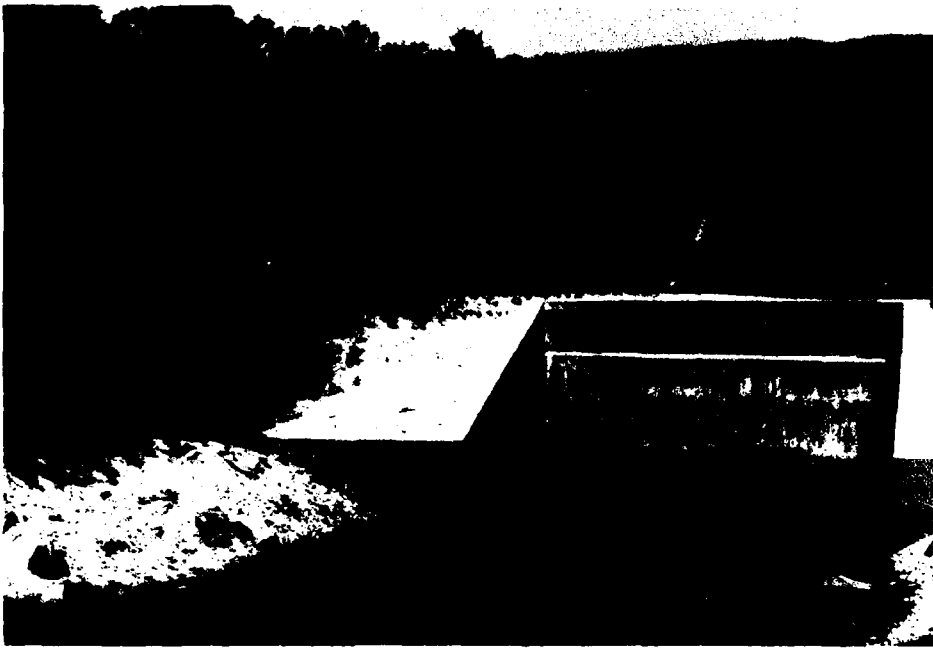
The slope is in good condition with an excellent turf and grass cover. There is an erosion channel on the face from the crest to the toe which has been formed by trespassing with trailbikes. This erosion channel can be seen in Photo 1.

OTO NO. 1 - Downstream face of dam and outlet structure

- 1) Repair all surface erosion channels.
- 2) Traffic barriers should be erected to discourage vehicular traffic on the dam.
- 3) Caps for the observation wells should be modified to allow easy access to the observation wells for future inspections.
- 4) The owner should develop a formal system for warning downstream residents in case of emergency.

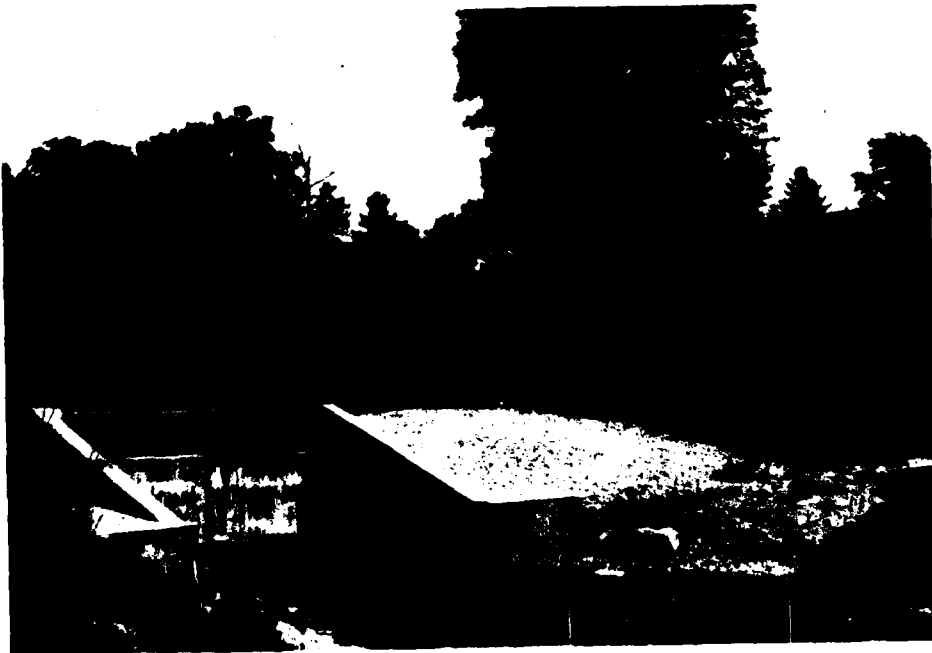
There was a damp area on the left abutment 150 ft. downstream of the dam axis and about 100 ft. left of the outlet pipe. The area, which is about 30 ft. long and 12 feet wide is shown in Photo 2. There was a small amount of surface water in the area at the time of inspection but no flow was observed. There is no siltation within the area and as can be seen in Photo 3, the area is well grassed.

OTO NO. 2 - Left abutment from outlet channel, inspection party at about the location of seepage area

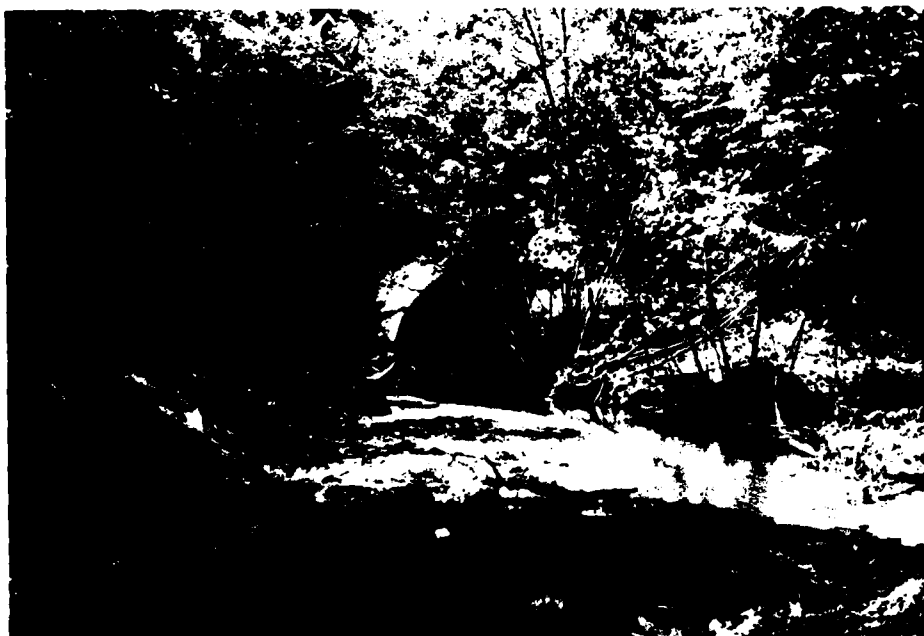
The outlet channel was examined and found to be in good condition. The slopes are wooded but pose no obstruction to free flow. The channel can be seen in Photos 7 and 8.

PHOTO NO. 8 - Outlet channel twin culvert at Mass. Pike
